**RE: Facility Assessment Report – City of Sherburn – Liquor Store**

# Facility Feasibility Study Report – Liquor Store

# Facility Feasibility Study – Photo Appendix

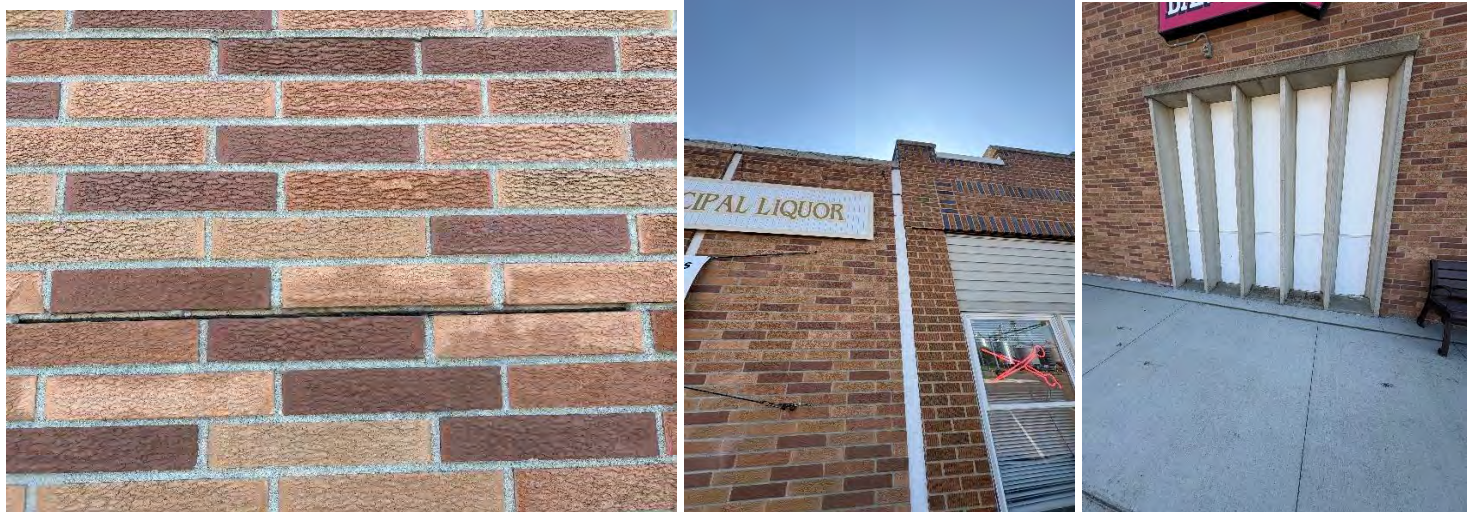
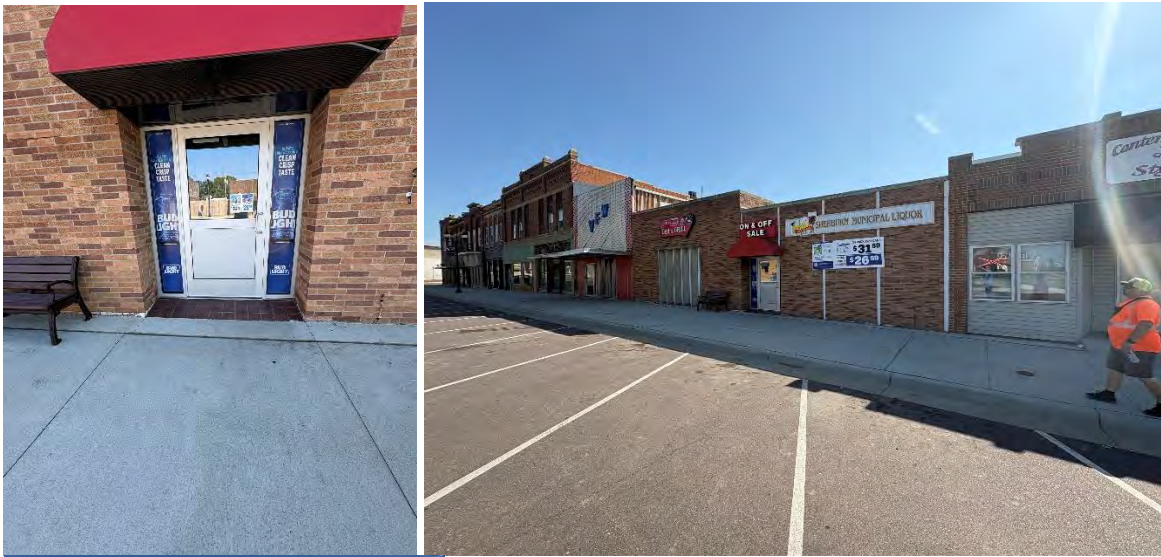
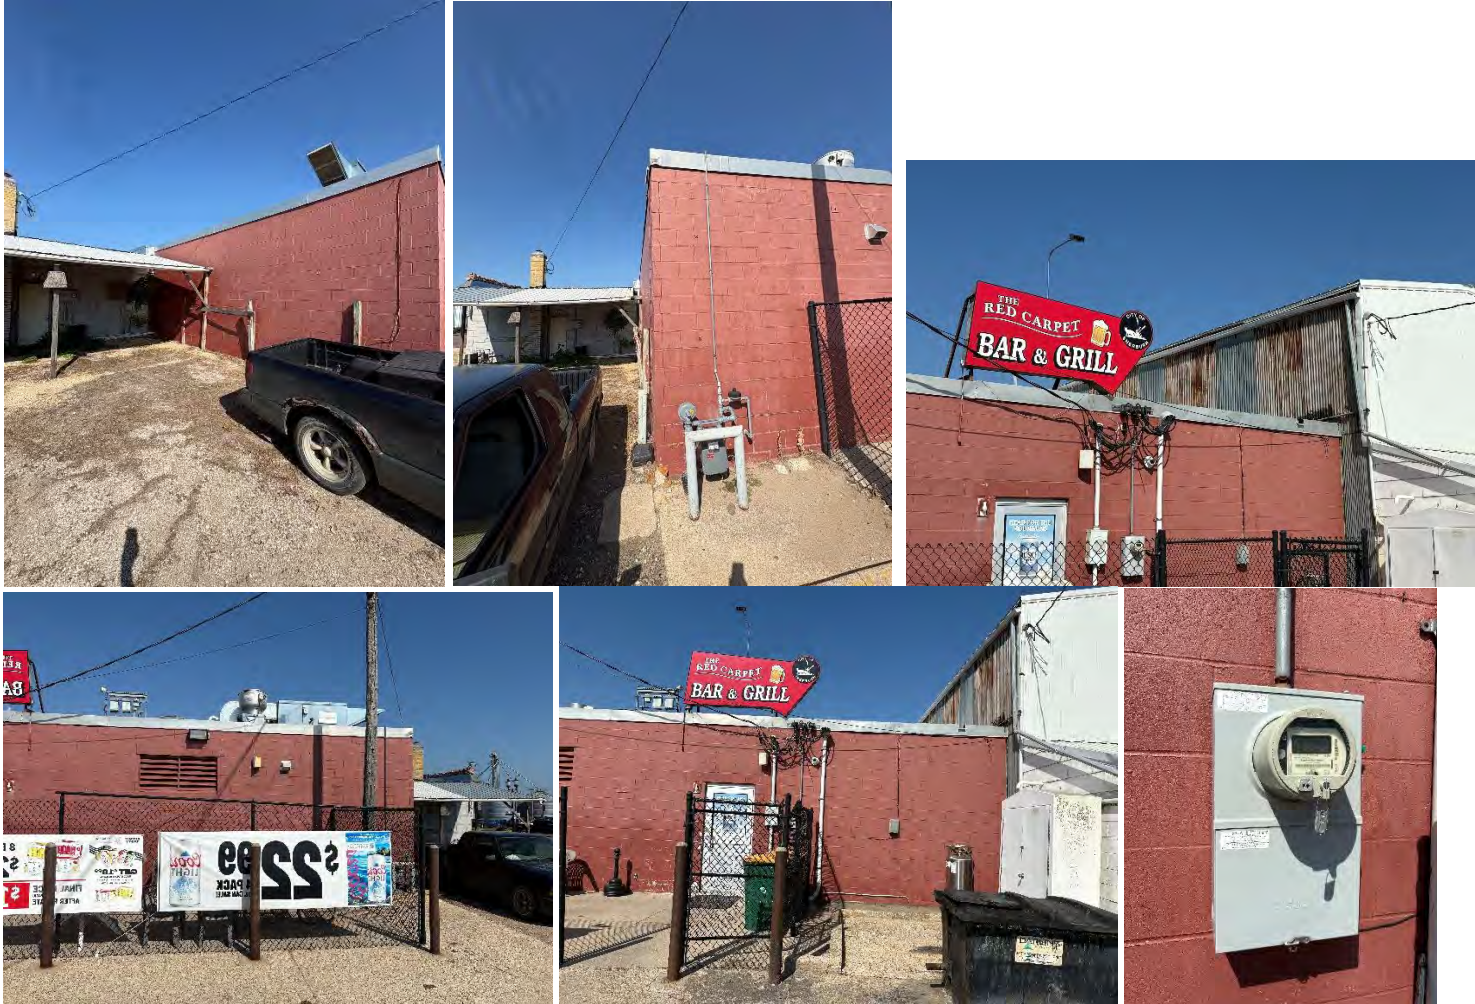
**Photo 1 – Building Exterior**

The North and South buildings provide a viable foundation for future investment. The single width CMU walls show signs of settlement cracking, mainly due to the lack of construction/control joints, the cracking is limited. No other structural issues are evident.

| Exterior Envelope | North/South: Masonry repairs required |

| Description | Reason/Risk | Rec Action | Priority |
|---|---|---|---|
| Exterior façade repair | Continued damage due to water infiltration/Low | Masonry repair of face brick, caulking, CMU painting and cornice cap | High |
| Cornice repair of capping | Cornice material deterioration | Repair deteriorating material or add flashing cap | High |

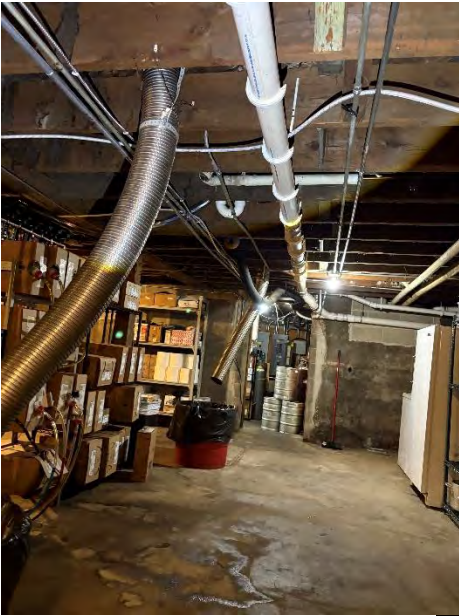
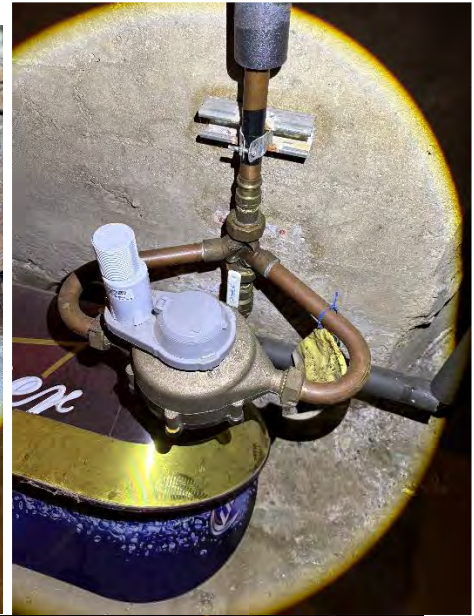
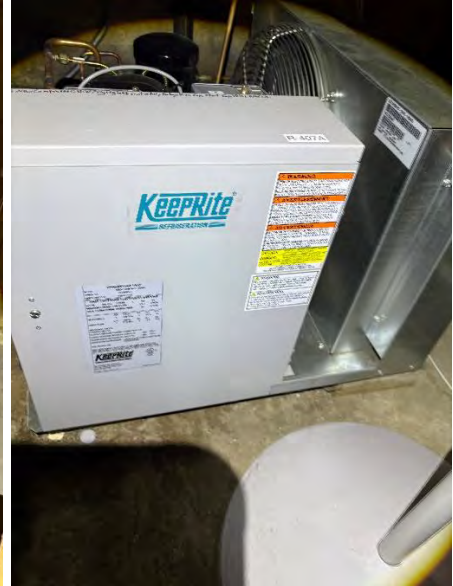
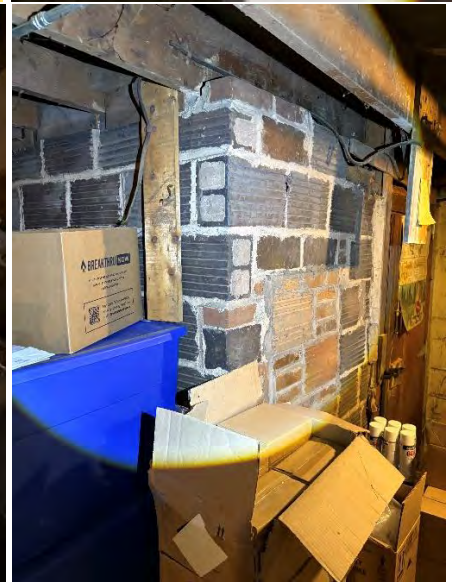
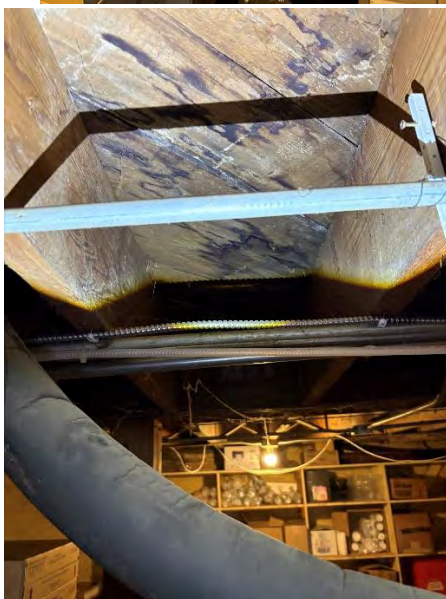
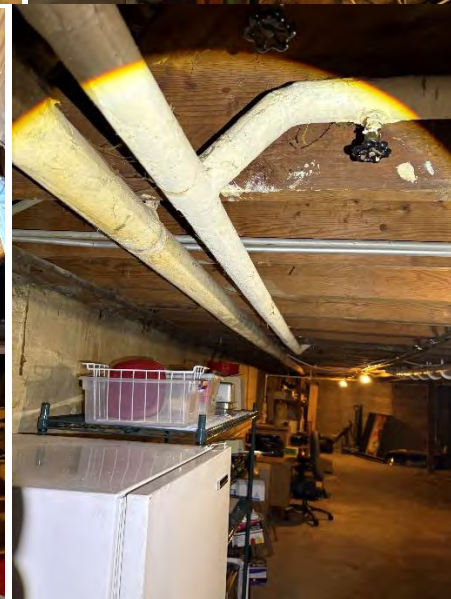
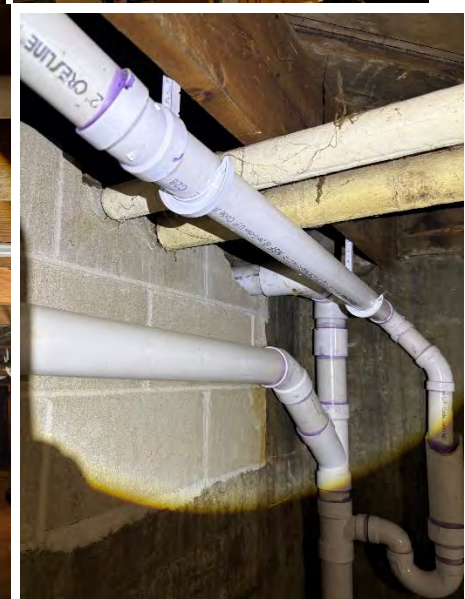
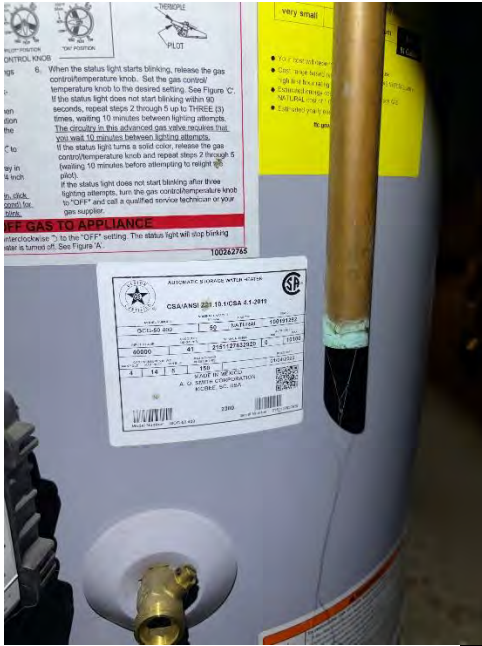
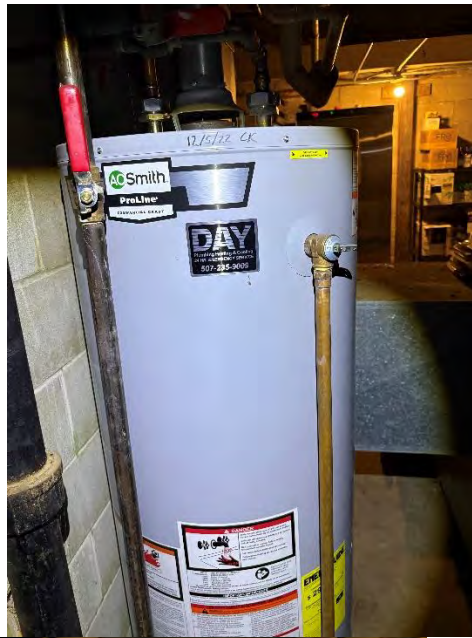
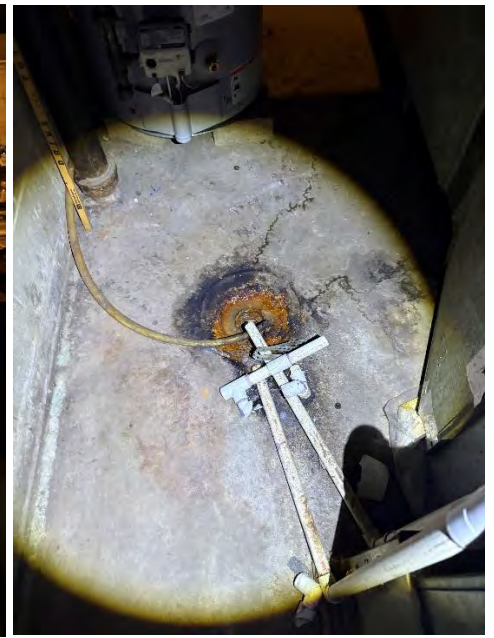
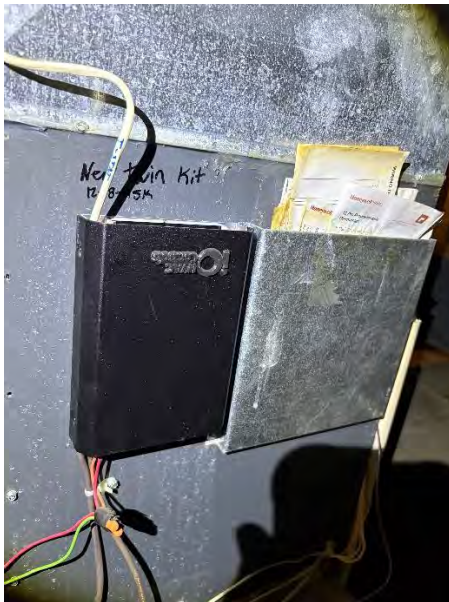
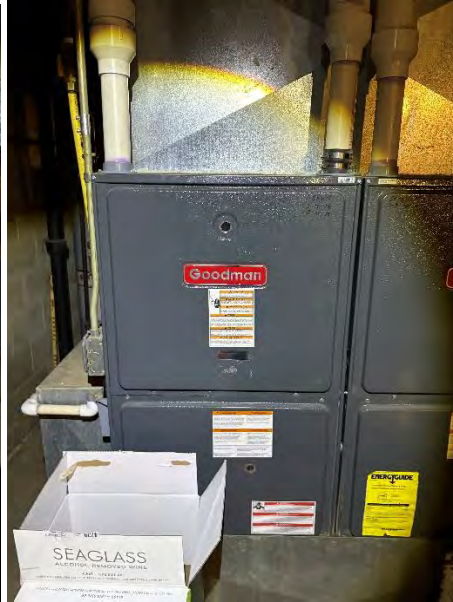
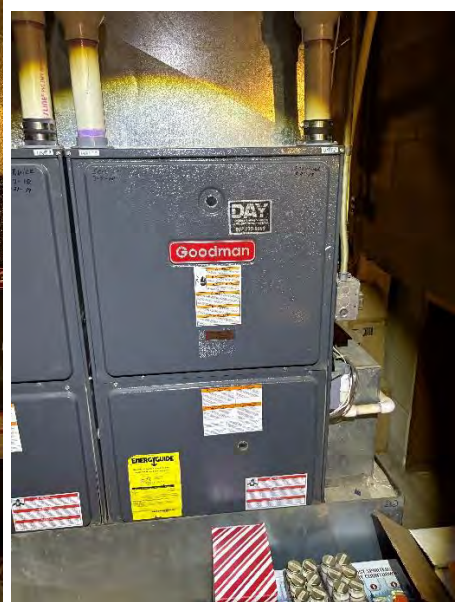
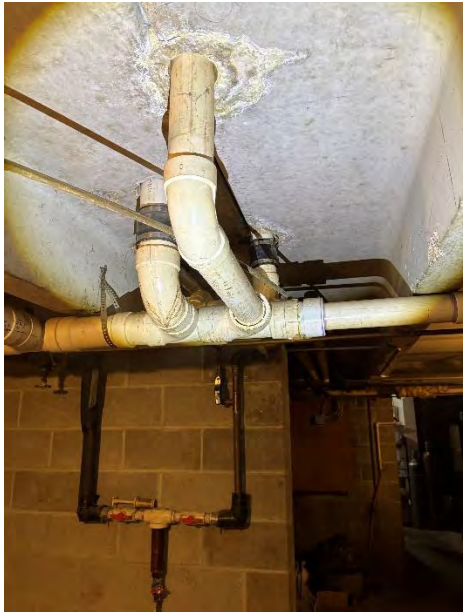
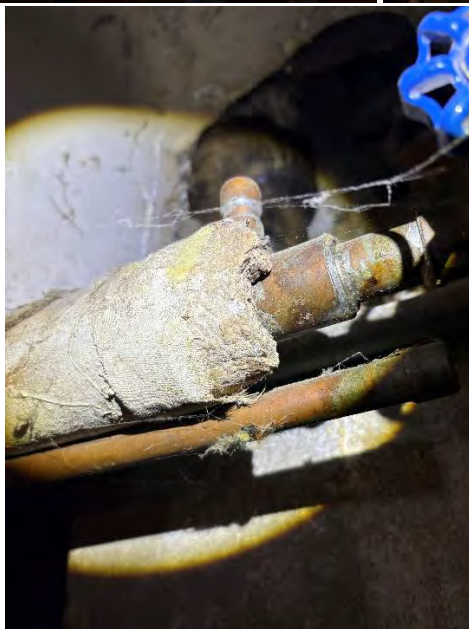
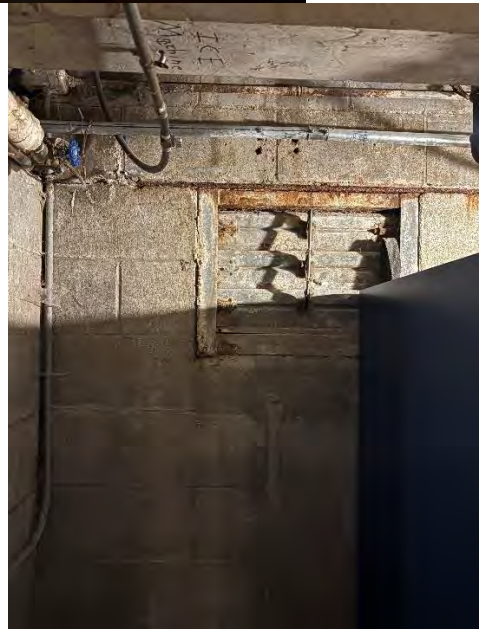
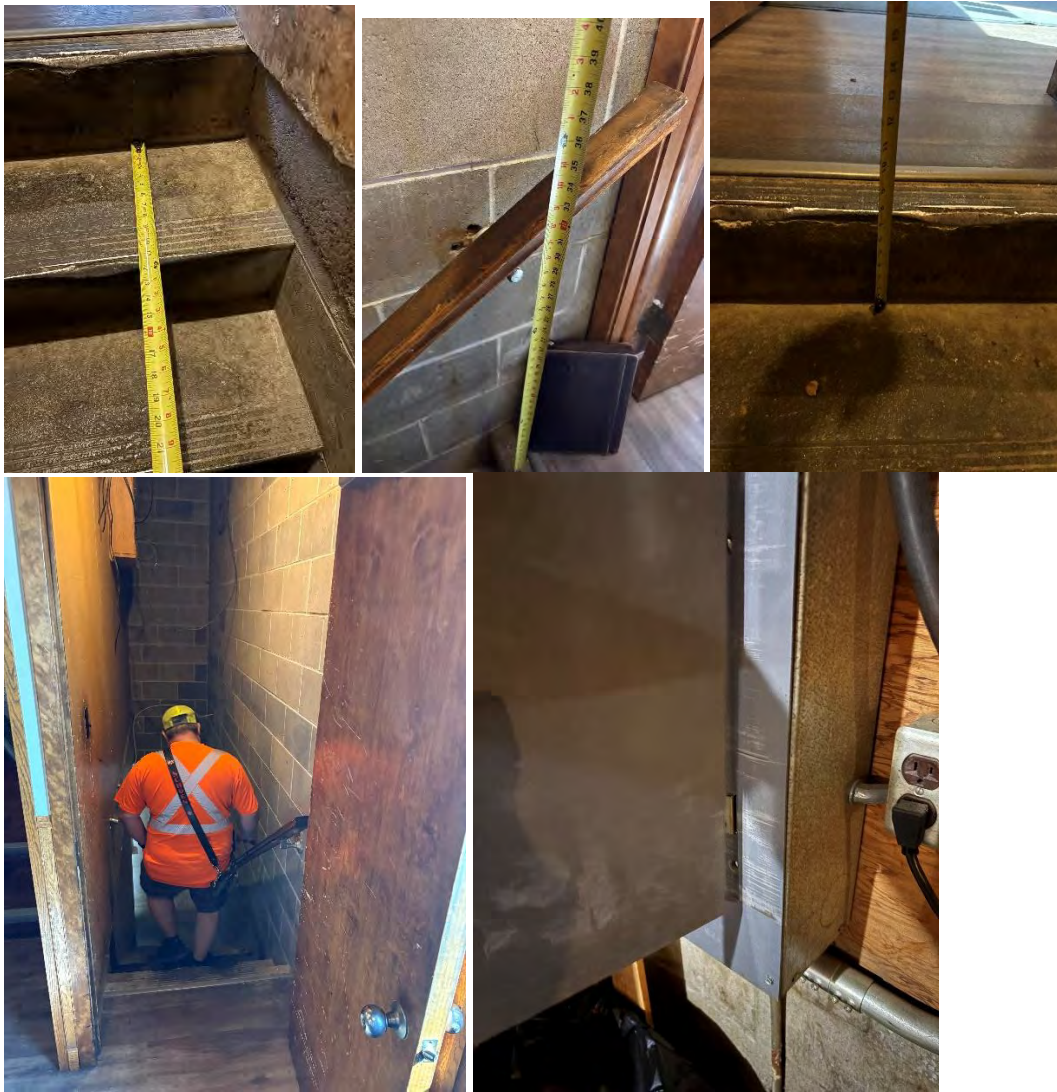
**Photo 3 – Basement Area**

The lower level does have an exterior vent that is rusted into place, the lack of conditioned or circulated air creates a dead air space at the lower level and condensation on surfaces with temperature changes.

The lack of ventilation/heating and moisture removal on the lower-level basement of both South and North buildings are an issue:

- Moisture accumulation at basement level with potential mold growth and health effects. Enclosed storage room at North building with potential mold growth, along with mildew along the South wall of the South building.

- Moisture accumulation at South building lower level, South wall with potential mold growth and health effects.
- Heat build-up at the compressor in the North building lower level should be addressed.

assessment, to better define potential cost and schedule impacts. Pipe insulation observed in the basement appears to be a linen wrapped material, and asbestos testing is strongly recommended before renovation, demolition, or disturbance.

A heating and ventilation system with moisture control or air conditioning should be installed on the lower level of the South and North buildings to supply moisture control and air circulation. Air-exchange or ventilation systems should also be installed at the basement levels of both the South and North buildings.

| Mold/mildew smell at North basement enclosed room | Mildew presence/High | Engage testing company and mitigate | High |
